**Flood Control Project Maintenance**  
**Levee Inspections**

**Fall 2011 Levee Maintenance Deficiency Summary Report**

**Sacramento River Basin**

**Sacramento Maintenance Yard Maintenance Area 0009**

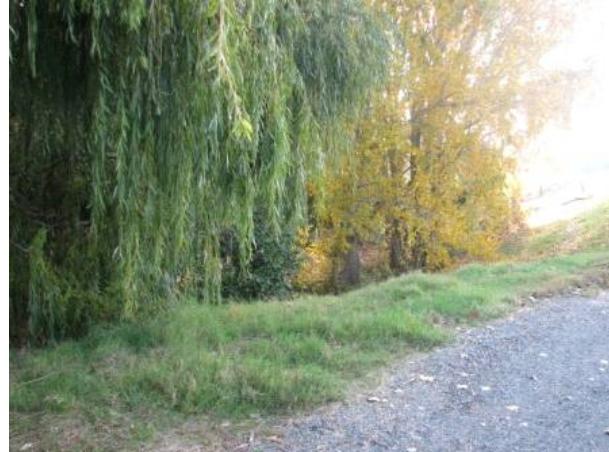
Levee Mile Report Line	216
Start Levee Mile	17.35
End Levee Mile	17.35
Location	Land Side
Category	Earthen Levee
Item	Encroachments
Trees are planted along the toe of the landside slope.	
johngw_f_20111007_913.jpg

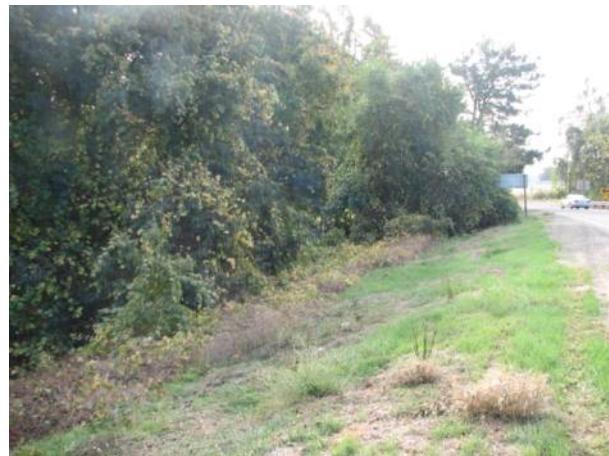
Levee Mile Report Line	217
Start Levee Mile	17.59
End Levee Mile	17.59
Location	Land Side
Category	Earthen Levee
Item	Encroachments
Trees and shrubs are planted to screen the house upstream of Hood. Fall 2011	
johngw_f_20111107_493.jpg

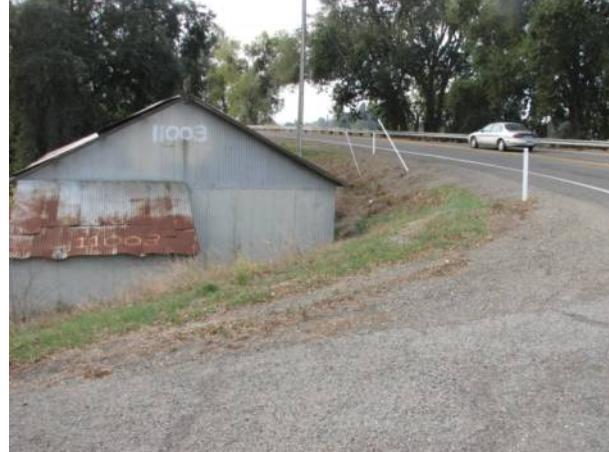
Levee Mile Report Line	219
Start Levee Mile	17.85
End Levee Mile	17.85
Location	Land Side
Category	Earthen Levee
Item	Encroachments
Old pumphouse downstream of Hood building cuts into the toe of the levee. Fall 2011	
<i>johngw_f_20111107_494.jpg</i>

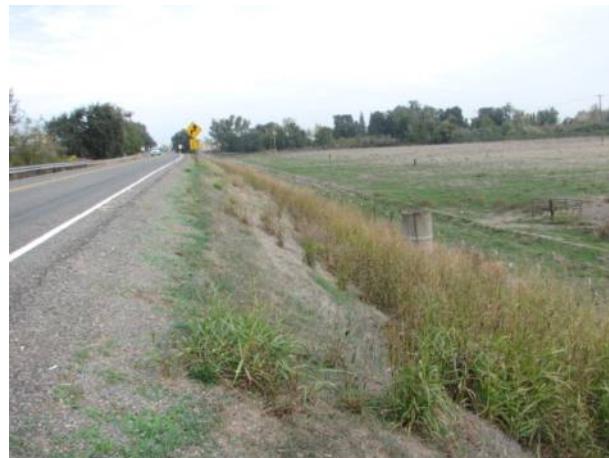
Levee Mile Report Line	220
Start Levee Mile	17.87
End Levee Mile	18.11
Location	Land Side
Category	Earthen Levee
Item	Vegetation
Johnson grass blocks the view of the toe. Fall 2011	
<i>johngw_f_20111107_495.jpg</i>

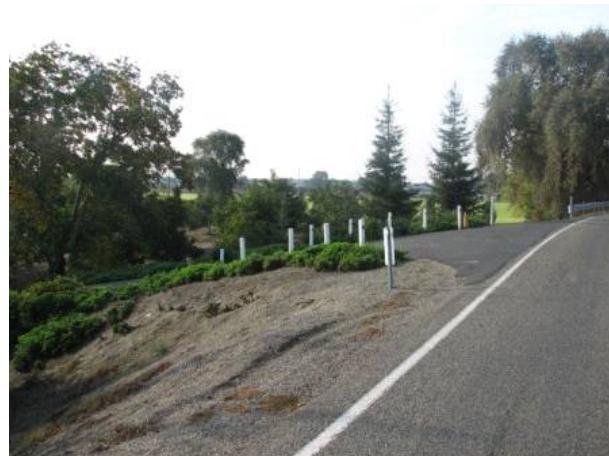
Levee Mile Report Line	222
Start Levee Mile	18.40
End Levee Mile	18.40
Location	Land Side
Category	Earthen Levee
Item	Encroachments
Groundcover and Redwood trees are planted on the slope and along the driveway.	
johngw_f_20111007_910.jpg

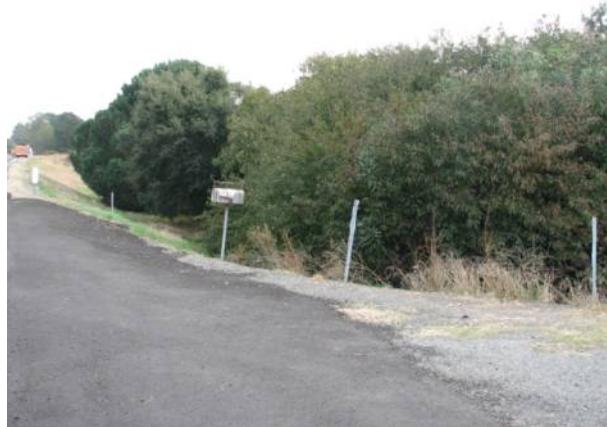
Levee Mile Report Line	229
Start Levee Mile	19.18
End Levee Mile	19.22
Location	Land Side
Category	Earthen Levee
Item	Encroachments
Oleanders line the driveway and are planted on the slope. Tall trees are planted at the toe. Fall 2011	johngw_f_20111107_497.jpg
